# **Factual Report**

**Fire Aboard Construction Barge *Athena 106*  
West Cote Blanche Bay, Louisiana  
October 12, 2006**

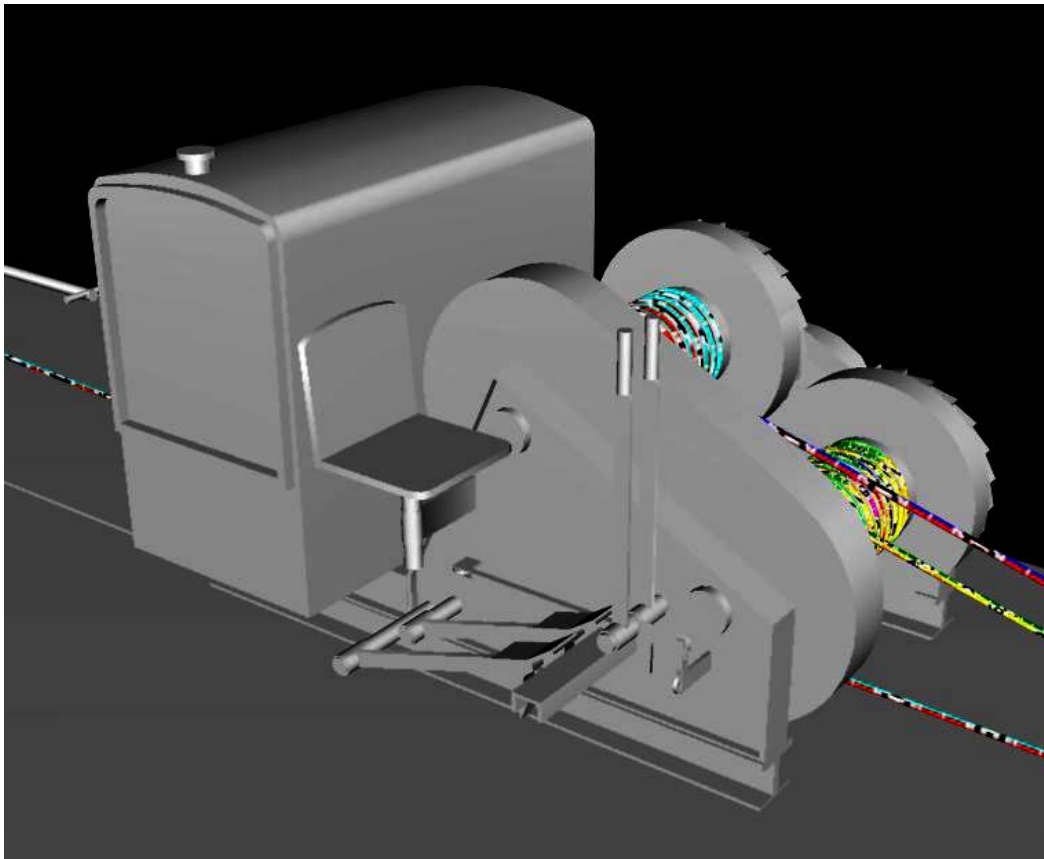
The spud winch operator's first duties of the day included checking the diesel and oil levels on the barge crane, checking the barge's air compressor, and checking the oil level in the spud winch gearcase as well as the general condition of the winch. Both spuds were raised and lowered by a single winch equipped with two steel cables, each wound around a drum and attached to one of the spuds (**figure 3**).<sup>4</sup> The spud winch operator said that he would periodically adjust the winch's foot brakes, which were used to control the speed of the winch drums as they raised or lowered the spuds. He said that on the day of the accident, the foot brakes "felt fine" and did not need adjusting. He

1 stated that he also checked the condition of the spud-lifting cables daily. Both spud winch  
2 cables had been replaced 2 months before the accident, according to documentation  
3 provided by the Athena Construction maintenance supervisor.

4  
5 **Figure 3.** Computer-generated image of a spud winch unit. The spud-lifting cables are  
6 wound on the drums to the left of the operator's seat. The winch's foot brakes are below  
7 and forward of the seat.

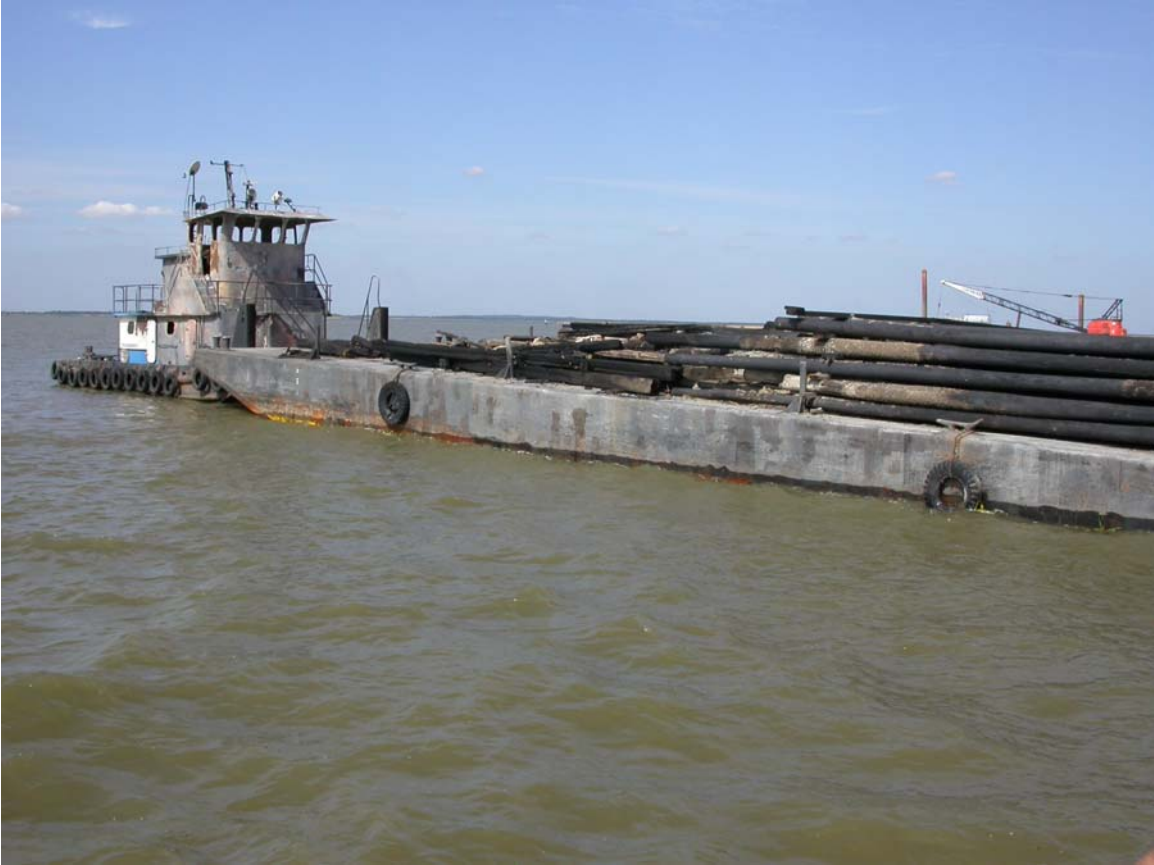
8 After completing the morning checks, the *Athena 106* crew began extracting  
9 pilings. The *IBR 234* was secured alongside the *Athena 106* to store the extracted pilings  
10 (**figure 4**). The barge also housed new pilings that would be driven later.

3  
4 **Figure 4.** Barge *IBR 234* loaded with pilings (being pushed by the *Miss Megan*).

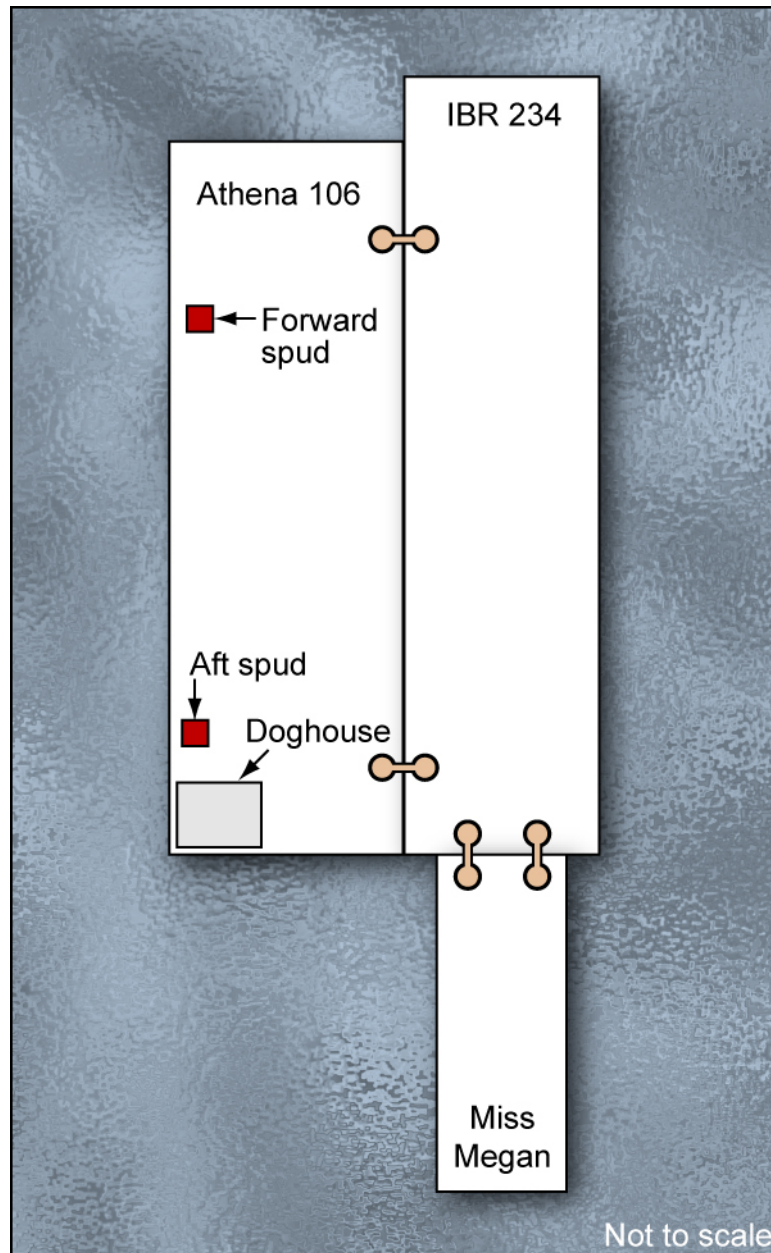
1 two barges to their next work location (**figure 5**). While the towboat master and  
2 deckhand made fast to the barges, the barge crew stopped its work of extracting pilings.

3  
4 **Figure 5.** Towing arrangement of the *Miss Megan* and the two barges. The barges were  
5 tied together, with the *Miss Megan* secured to the aft end of the *IBR 234* and pushing  
6 both barges.

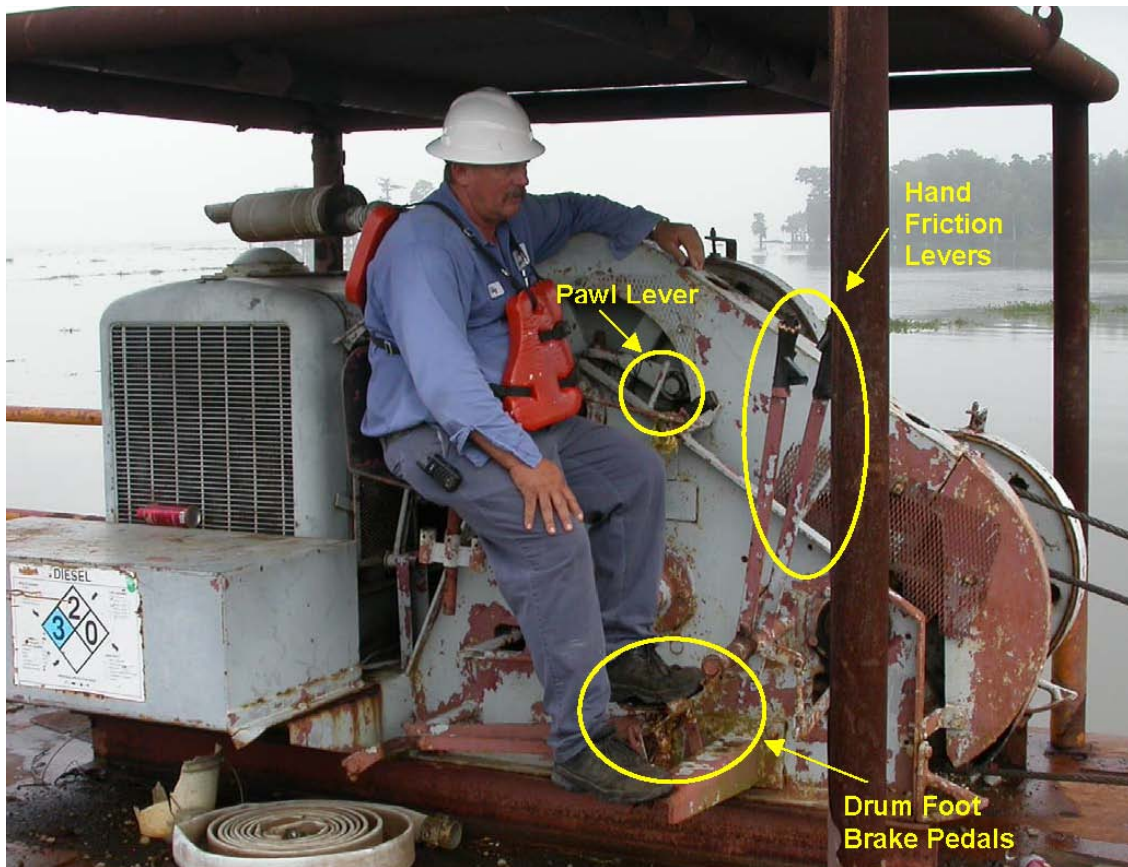
7       The spud winch operator could control the drums independently, working from a  
8       seat mounted on the inboard side of the winch, facing the forward end of the barge  
9       (**figure 8**). Each winch drum had two brake bands, one on the outside and one on the  
10      inside nearest the operator. Both bands were controlled from the operator's seat, the outer  
11      band by a foot lever and the inner band by a hand control lever. Thus, the operator had  
12      two foot brake pedals and two hand levers that acted as friction brakes to control the  
13      speed of the winch drums as they lowered or raised the spuds. The operator's winch  
14      controls also included (1) a single-lever throttle to control the diesel engine's speed, (2) a  
15      lever for engaging or disengaging the diesel engine's clutch from the winch drum  
16      driveshaft (used only while lifting the spud; lowering the spud was accomplished by

4  
5 **Figure 8.** Operator in position at the spud winch on another Athena barge, not the  
6 *Athena 106*, used in the salvage operation after the accident. Highlighted are the foot  
7 brake pedals and hand levers that controlled the speed of the winch drums as they  
8 lowered or raised the spuds, and one of the levers that engaged or disengaged the drum  
9 pawls into a notched ring on the drums' outer edge to prevent the cables from paying  
10 out. Note the operator's work vest, the flotation device worn by barge workers on the job.

11 With the engine running and the clutch engaged, the spud winch operator would  
12 pull back on the appropriate (forward or aft) spud's hand lever to increase friction to that  
13 drum, thereby rotating the drum and lifting the spud at the end of its cable. Once the spud  
14 was fully raised, the operator would latch the foot brake in place by depressing it. He

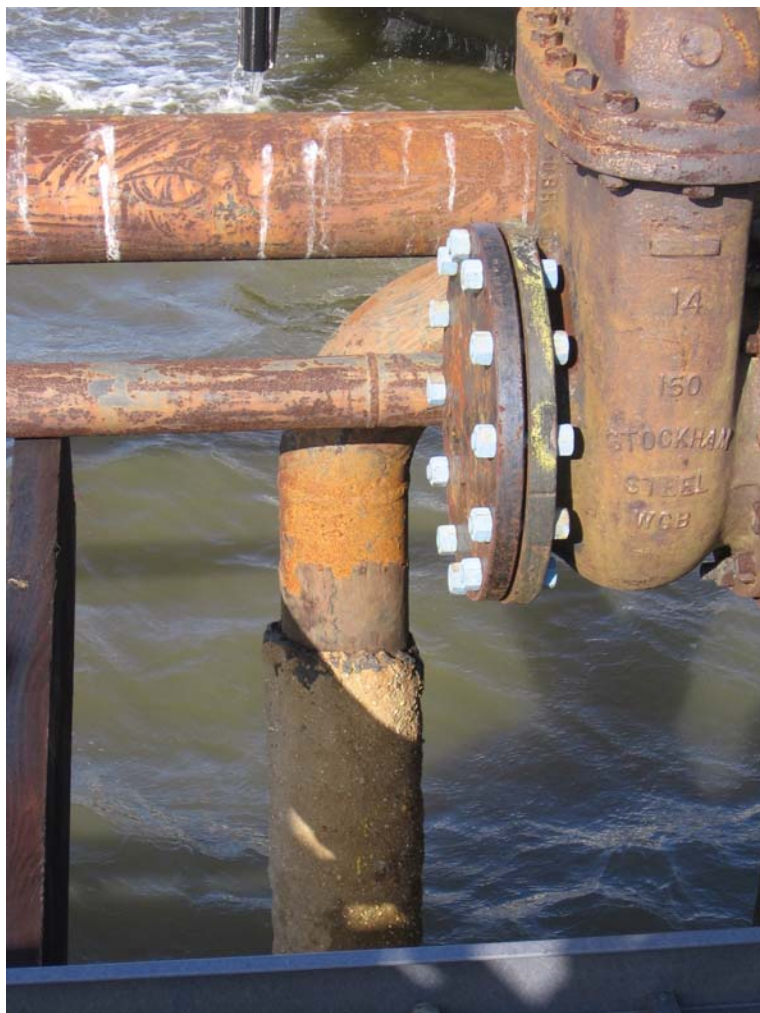
1           At the point where it was struck, the gas sales pipeline ran roughly east to west  
2   under the bay (**figure 1**). West of where it was struck, the pipeline made a 90-degree turn  
3   north. At the east end, the pipeline began at the Gulfport sales platform (**figure 14**). The  
4   sales platform was in Gulfport's West Cote Blanche Bay production field (state lease  
5   340). At the west end, the pipeline terminated at Chevron's bay junction platform, where  
6   it tied into Chevron's Vermilion Bay gas sales pipeline. A check valve downstream of the  
7   tie-in prevented backflow from the downstream gas-gathering system.

8  
9   **Figure 14.** Beginning of the gas sales pipeline (vertical pipe entering water) at the  
10 Gulfport sales platform in the West Cote Blanche Bay oil field. The pipeline was ruptured  
11 by the *Athena 106*'s aft spud in an east-west section near the Gulfport platform. The  
12 pipe's concrete coating is visible above the waterline.

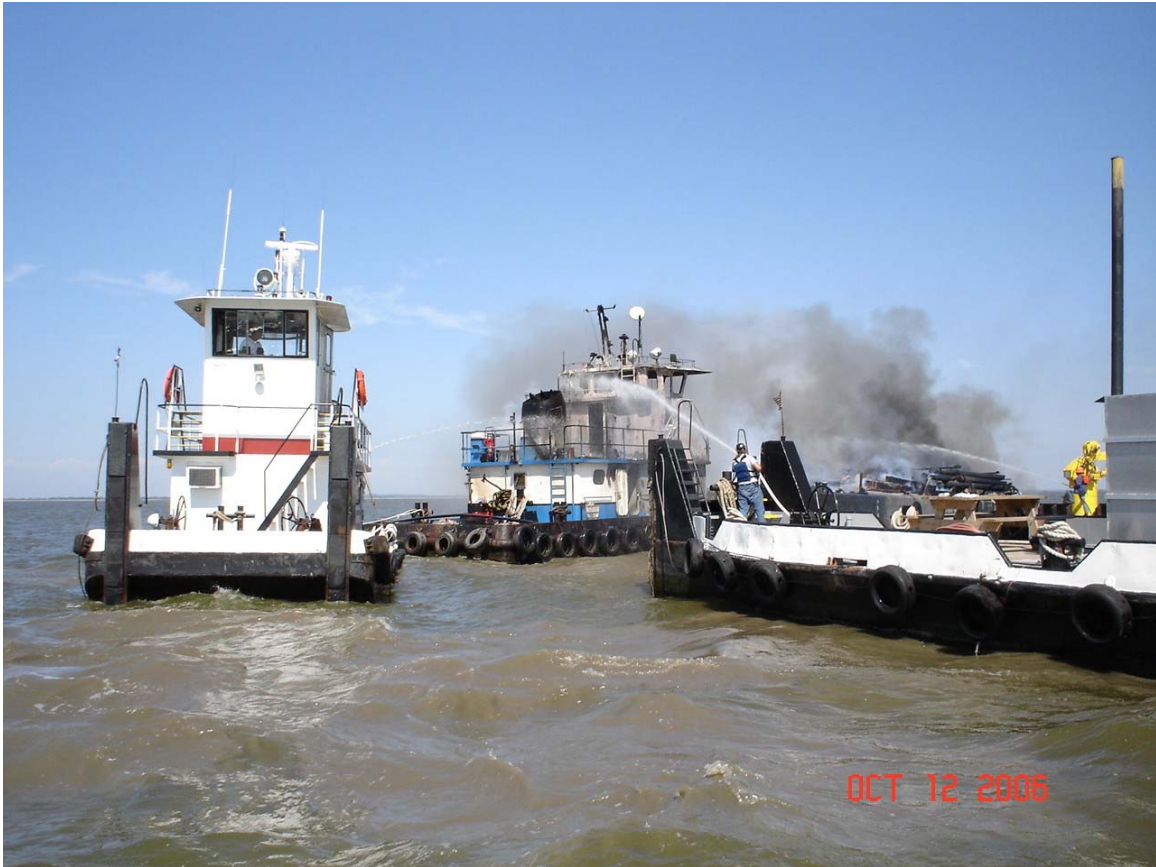
1 course of several hours, the three vessels extinguished the fires on the *Miss Megan* and  
2 the two barges (**figure 15**).

3  
4  
5 **Figure 15.** Towboats *Miss Joann* and *Yancy O* fighting the fire on the *Miss Megan* and  
6 the deck barge *IBR 234*. (Photo courtesy Louisiana Department of Wildlife and  
7 Fisheries)
